Windy Curve Farm Near Galena mid-19th Century

Survey No. K-631

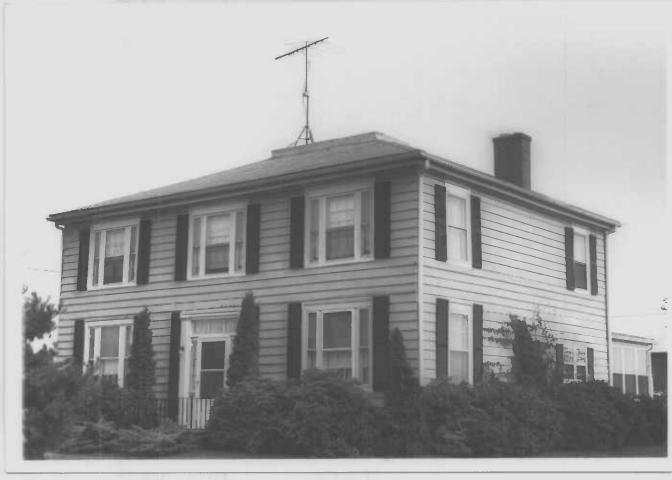
K-631 Windy Curve Farm Old Galena-Massey Road, near Galena M. Q. Fallaw - 6/16/86 View to southeast

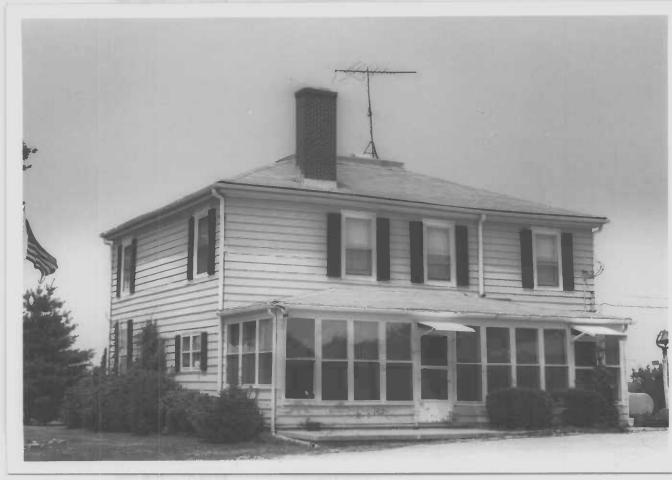
K-631 Windy Curve Farm Old Galena-Massey Road, near Galena M. Q. Fallaw - 6/16/86 View to northeast
